***Seismic Performance of Historical and  
Monumental Structures***

# Seismic Performance of Historical and Monumental Structures

Halil Sezen and Adem Dogangun

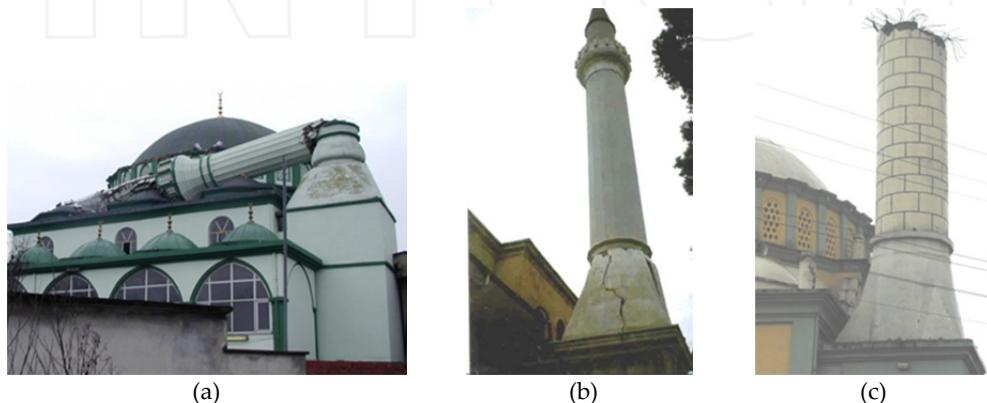
As illustrated in Figures 6b and 6d, percentage of all damaged minarets and only RC minarets are similar. Almost forty percent of the minarets collapsed, and approximately one third of the minarets were undamaged. Failure plane for almost all collapsed RC minarets was within 1.5 meter long region above the minaret base or pyramid-shaped transition segment (Figure 7a), where the longitudinal reinforcing bars were usually spliced. Horizontal circumferential cracks and spalling of concrete were commonly observed at the bottom of the cylindrical body of RC minarets (Figure 7a). Frequently, flexural cracks, concrete crushing or spalling was observed in this region of the damaged RC minarets. As shown in Figure 7, less frequently collapse or damage occurred within the transition segment and middle of the cylindrical body or near the top of the minaret.

**Figure 7.** Collapse of a minaret near the bottom of cylinder (left), minaret damage within transition segment (middle), and collapsed minaret at mid-height of cylinder (right)

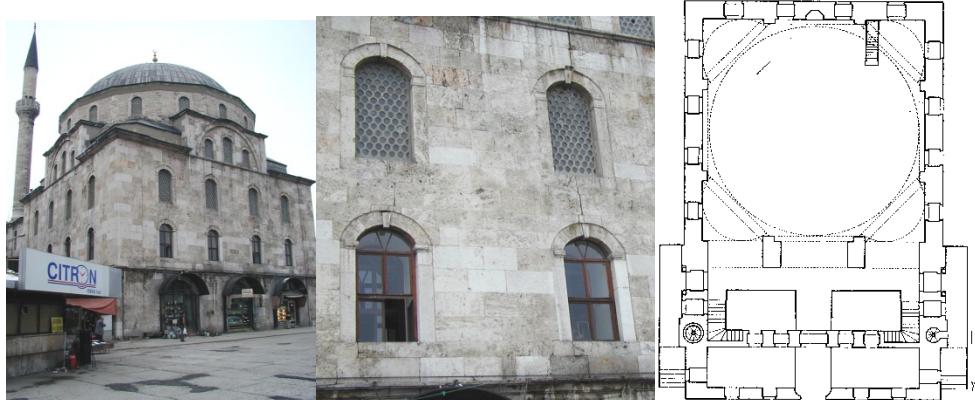
**Figure 9.** Wall damage and plan view of historical Yildirim Bayezid mosque in Bolu

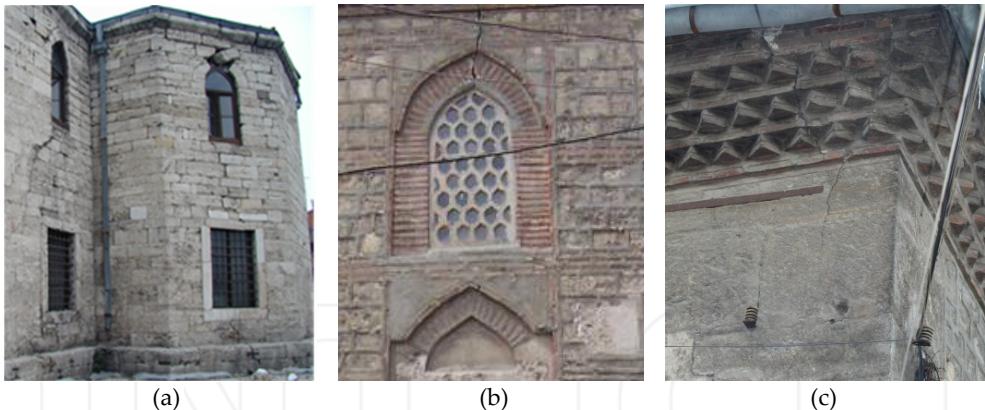
Another historical mosque, Kadi (Figures 8b and 10a) sustained substantial damage including large cracks around historical entrance door, severe cracks and stone dislocations in the 1.5 m wide unreinforced stone masonry perimeter walls. Damage was mostly concentrated below or above the windows. The missing two key keystones and dislocated stones on top of the upper window are visible in Figure 10a. The reduced wall area along the vertical section through the windows was stressed more, causing considerable damage in those wall areas. The stone masonry minaret collapsed right above its base because the minaret base was integral with minaret walls (Figure 8b) and was quite stiff compared to the cylindrical minaret body.

**Figure 10.** a) cracks developed in the walls and above windows of Kadi; and b, c) damage in the walls of Sarachane mosque
