***Ground Remote Sensing Techniques for Supporting  
an Early Warning Water-Leakage System***

# Investigation of Ground Remote Sensing Techniques for Supporting an Early Warning Water-Leakage System

Athos Agapiou, Dimitrios D. Alexakis,  
Kyriacos Themistocleous, Apostolos Sarris,  
Skevi Perdikou, Chris Clayton and  
Diofantos G. Hadjimitsis

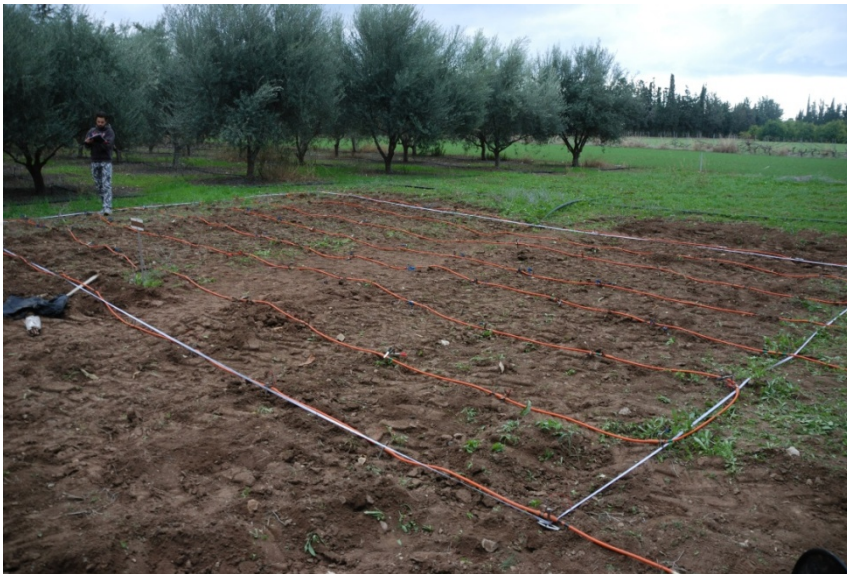
**Figure 1.** Area of interest. A pipeline was buried at a depth of approximately 1 meter.

In this area, a pipeline was buried 1 meter below surface. Cracks were produced in the pipeline in order to create an artificial leakage event. The end of the pipeline was connected to a valve. Figure 2 shows the area of interest approximately one hour after the artificial leakage event.

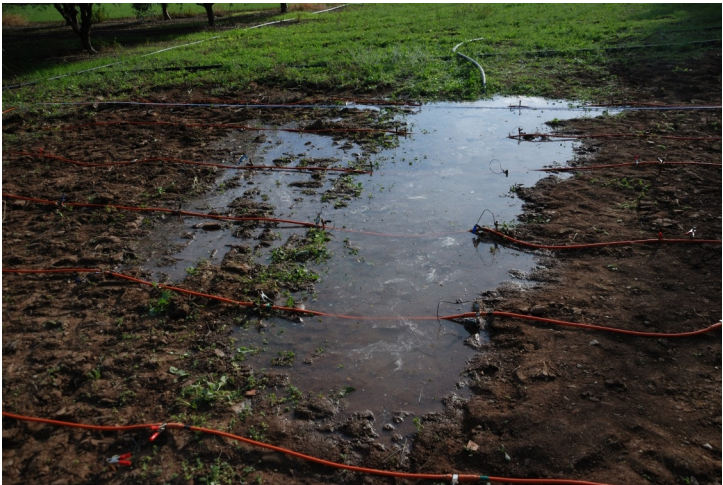
Figure 2. Leakage as observed from the surface

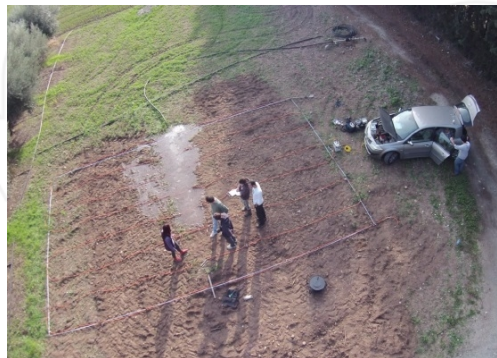
Figure 4. Leakage event in Mandria as observed from UAV

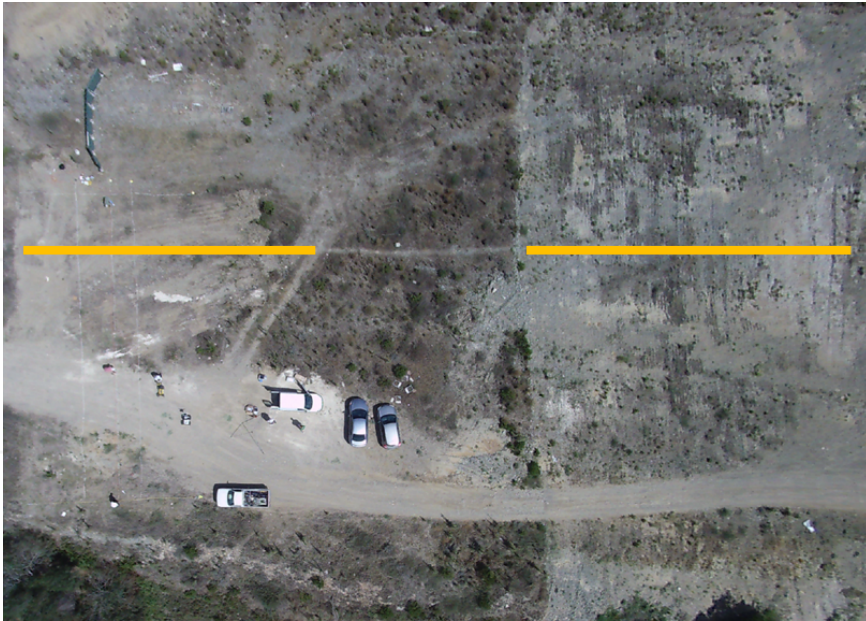
**Figure 5.** Lakatameia underground pipeline as observed from UAV

and imaging can be conducted using large scale low-altitude imaging and geospatial information (Colomina and Molina, 2014; Cho et al, 2013; Mayr, 2013; Petrie, 2013). In this study, a UAV platform was used to take aerial images of the study site. The UAV was equipped with RGB and VNIR cameras in order to document and detect water leakages from a low-altitude position. In this study, an octo-copter with 8 motorized propellers, including a GPS, piezo gyros, compass, altitude control, telemetry, acceleration and barometric sensor was used (figure 3.) The copter was used to take photographs of the water leakage events. Figure 4 features an aerial view of the Mandria water leakage site, while Figure 5 clearly shows the Lakatameia underground pipeline via aerial photography, with the continuation of the pipeline in yellow.

It was found that, in some cases, the UAV can identify water leakages and water pipelines in different ways such as increased vegetation along the pipeline where the water leakage occurs, change of soil characteristics along the pipeline route (Figure 5), as well as changes in the reflectance value of soils in the water leakage area. UAVs can also be used with thermal and infrared cameras to identify changes in temperature due to water leakage. An additional benefit of UAV platforms is that they can be used to survey large areas to provide overall coverage of the area or it can be used for areas that are inaccessible. The integration of UAV with other techniques is a useful method to cross-validate the leakage event.

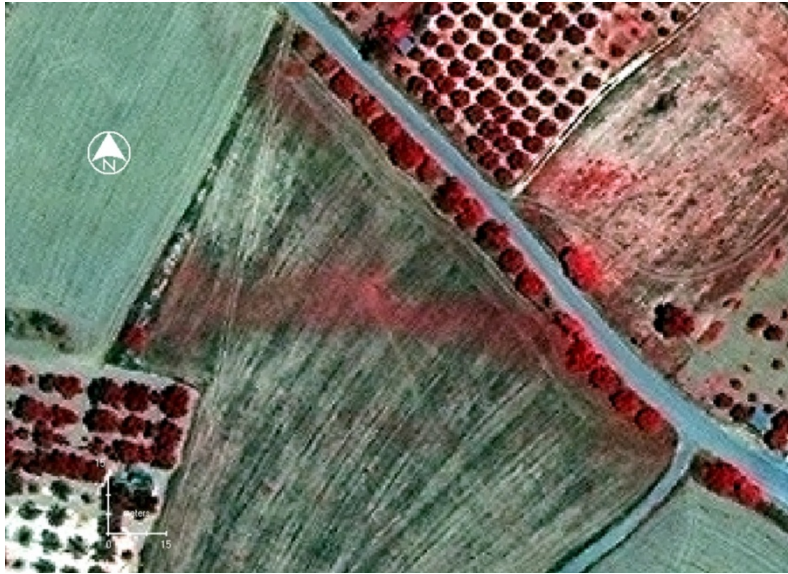
**Figure 27.** Detection of leakage problem using high resolution satellite data (Agapiou et al. 2014)

The modeler was built into the ArcGIS environment and successfully applied using several satellite data. Previous studies of the authors (Agapiou et al. 2014) the detection of leakage events was possible (see Figure 27).
