The Problem of Water Leakages

1. Introduction — The problem of water leakages

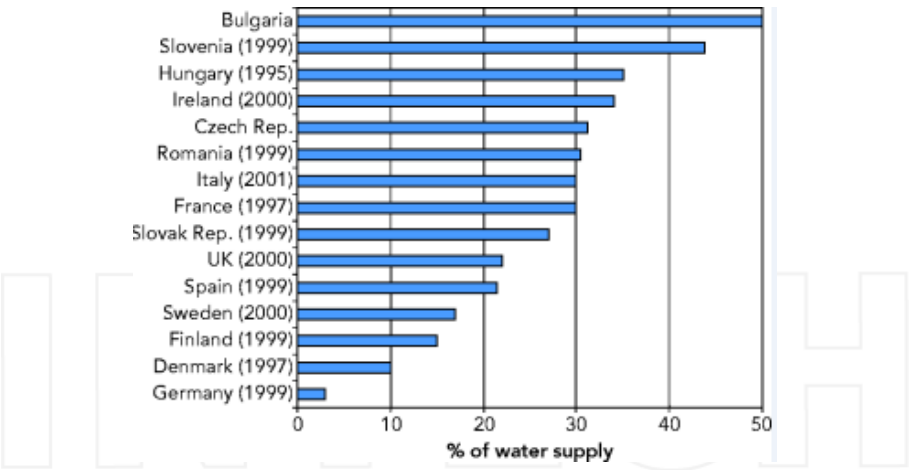
Figure 1. Losses from urban water networks. (): Year of data. (<http://www.eea.europa.eu/legal/copyright>). Copyright holder: European Environment Agency (EEA, 2008).

A significant amount of water is lost in the water supply system. Water leakages have been a major problem for many regions around the world (Weifeng et al, 2011). In some countries water loss due to water leakages in the supply network exceeds 40% of the water in the supply system (Fig 1). Reduction of water leakages is an important goal for many countries in the world (Vairavamoorthy and Lumbers, 1998), as it will mean a reduction in the amount of money and energy required on producing and pumping water and also satisfaction of consumer needs through improved reliability of the system (Ayala–Cabrera et al, 2013).

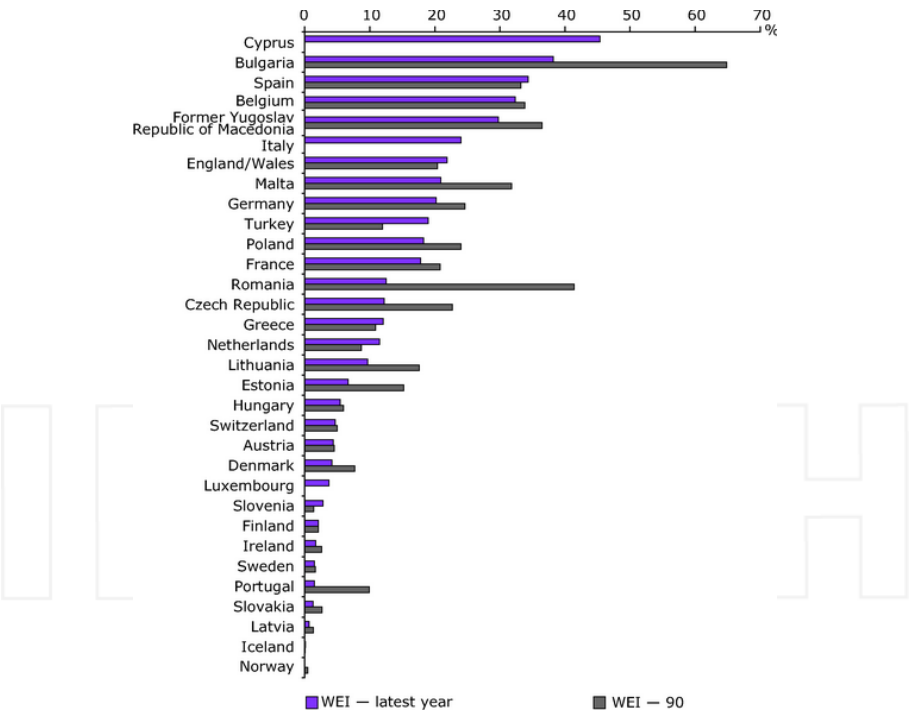
Figure 2. Total water abstraction per year as a percentage of the total long-term renewable resource. (<http://www.eea.europa.eu/legal/copyright>). Copyright holder: European Environment Agency (EEA, 2008).

The Eastern Mediterranean countries are expected to be affected adversely by climate change. Similar to other countries in this region, Cyprus has semi-arid climate with limited water resources (Zachariades, 2010). This, combined with the high water demand on the island, resulted in Cyprus having the highest Water Exploitation Index across Europe WEI (Fig 2). A WEI above 20 % implies that a water resource is under stress and values above 40 % indicate severe water stress and clearly unsustainable use of the water resource (Raskin et al., 1997).

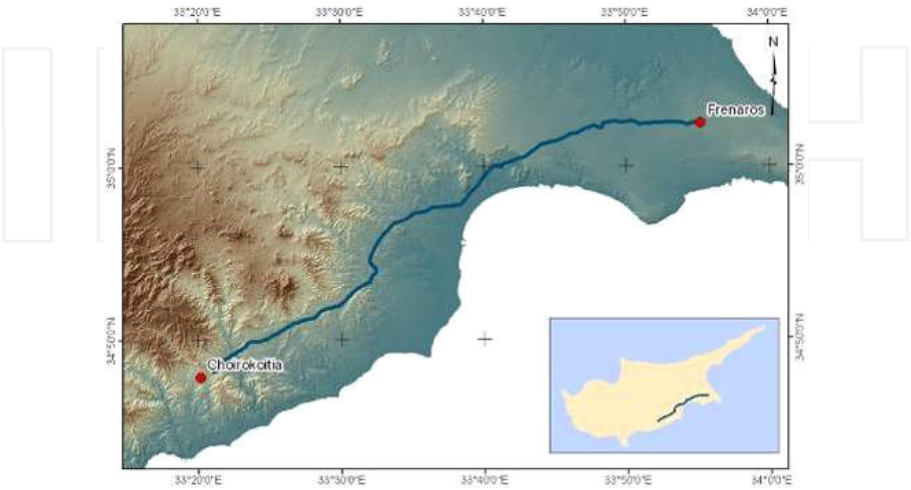
Figure 3. The “Choirokoitia-Frenaros” water pipe

In order to identify and monitor water leakages, 3 case studies are described in this section: (a) Frenaros-Chirokeitia (b) Lakatamia and (c) Germasogeia water pipe network. The first case study Frenaros-Chirokeitia (Fig 3) is a major rural pipeline in Cyprus, which runs from the *Chirokeitia* area to the *Frenaros* area. The existing pipeline, which passes through the central and central-east part of Cyprus, has a length of over 65 km. The pipeline is located 1-3 meters below ground surface. Various geological formations, generating several soil types including calcaric cambisols, calcaric regosols, and epipetric calcisols, exist in the area, while the higher

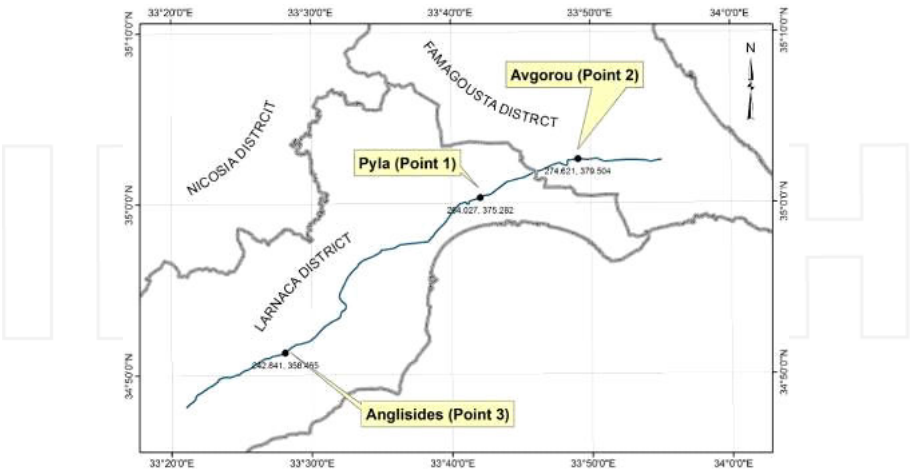
Figure 4. Points 1-3 indicate the spots were water leakages have been reported in the “Choirokoitia-Frenaros” water pipe.

and lower elevation of the pipeline (ground surface) is estimated to vary between 10 m and 200 m above sea level. From 2007 to 2010, three major leakages were observed along different sections of the pipe (Fig 4). The locations of these leakages were not detected at once after the leakage occurred. The leakages occurred during 2007, 2008 and 2010; further details for these events are described later in the book.

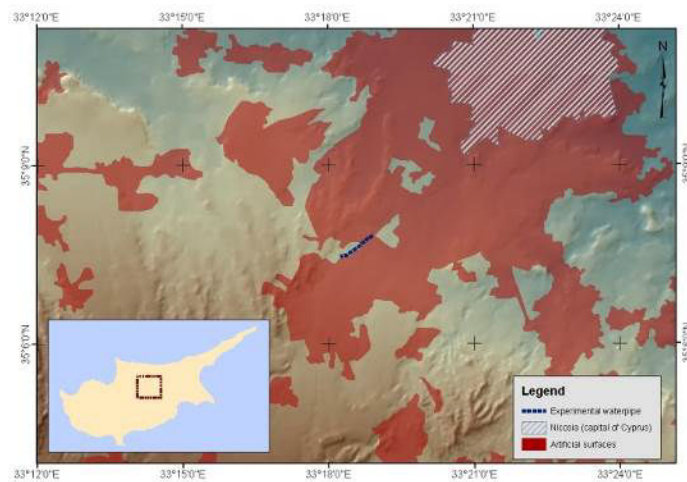
Figure 5. The “Lakatamia” water pipe

The Lakatamia water pipe (Fig 5) has a length of less than 5 km and has been systematically reported as problematic due to several leakages and it is therefore no longer in use by the local authorities. The pipe runs through urban and rural areas. A section of the pipeline, with a length of over 2km and located in a rural area, has been used for the detection of leakages. Since the existing water pipe is not currently in use, it was necessary to fill the pipe periodically with water to observe the effectiveness of such remote sensing non-contact techniques. The water pipe is made of UPVC and has 315mm diameter. It is between 1.80m and 2.00m below the ground surface and runs along the *Pediaos* River for a large part of its length. It is currently not being used due to water leakages occurring throughout almost the entire length of the pipeline. Information regarding the specific dates of events is not available from local authorities.

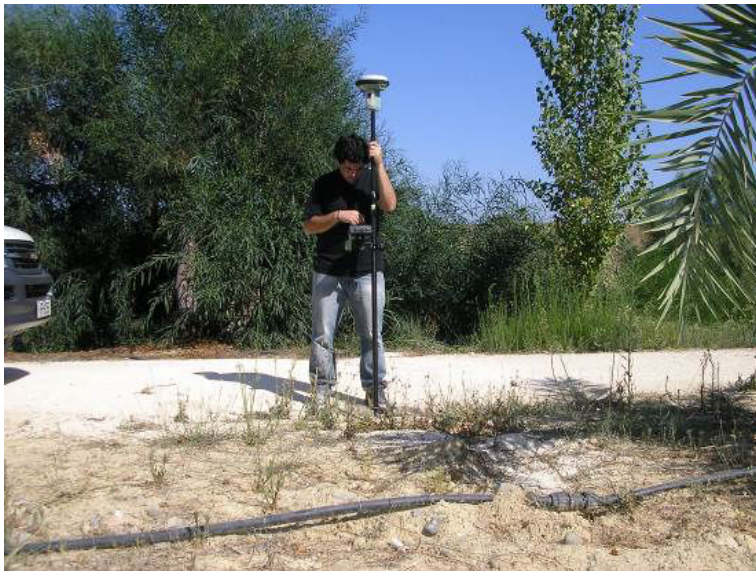
Figure 6. GPS measurements in the Lakatameia pipeline.

For all three case studies, the first step was to georeference the water pipes under examination. For the “Chroirokoitia-Frenaros” water pipe, all data regarding the characteristics of the pipeline were collected in CAD format from the Water Development Department—which is the responsible authority for the water pipe. In addition, the coordinates of the leakages were collected and added in a GIS environment. The GIS environment allows the researchers to identify potential areas which are suitable for the detection of the event, so they can be identified on satellite images. Soil, land use and meteorological data were also included in the GIS environment. A similar approach was followed for the “Germasoyeia-Moutagiakia” pipe line. The CAD file was converted into a :shp file and imported into a GIS database. For the pipeline in the area of Lakatameia, GPS measurements were carried out to map the path of the pipeline (Figure 6; Figure 7). Engineers from the municipality of Lakatameia also indicated problematic spots over the buried pipeline, which were recorded in the data. Figure 7 shows the pipeline as mapped from the GPS measurements (with red line, background Google Earth).

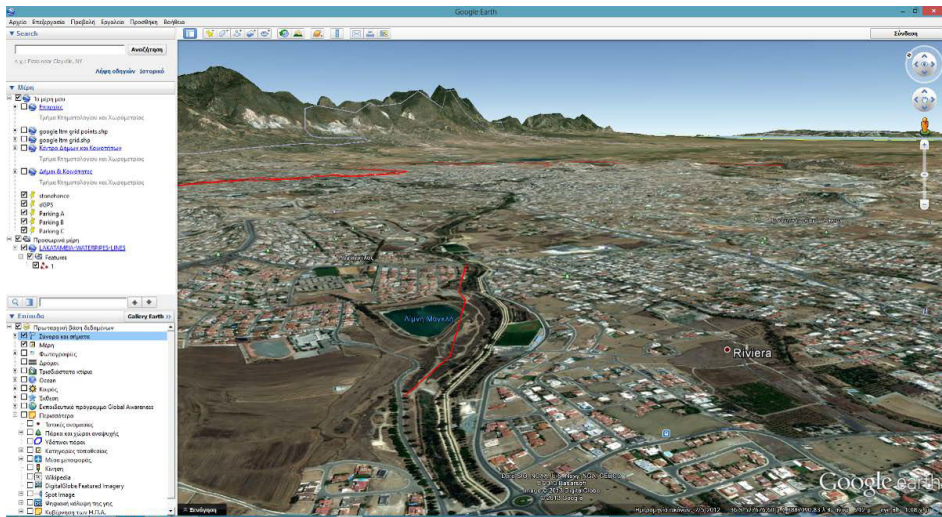
Figure 7. Pipeline as mapped from the GPS measurements (with red line, background Google Earth).

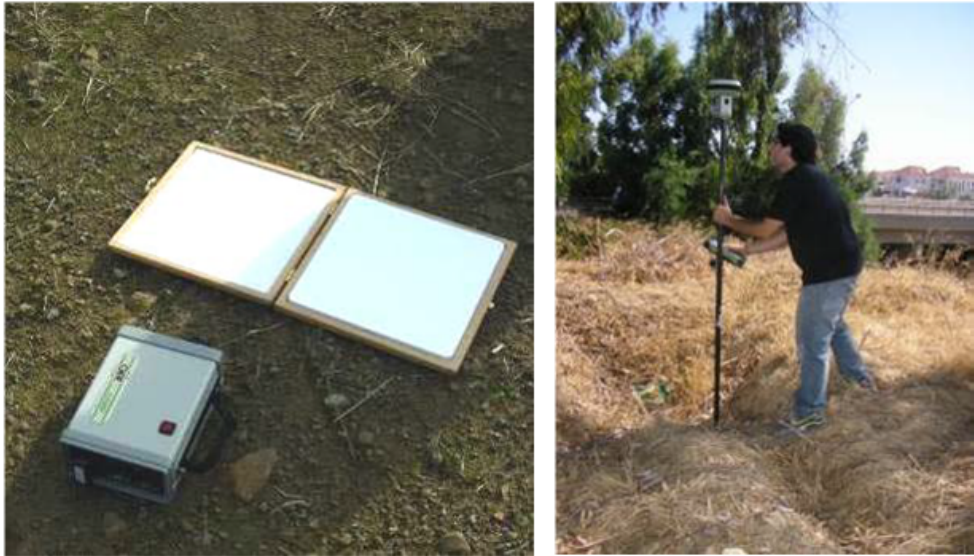
Figure 8. a) (left): The GER 1500 spectroradiometer used for the collection of ground measurements and b) (right): the GNSS used for mapping the pipeline

In order to avoid any errors due to changes in the prevailing atmospheric conditions (Milton et al. 2009), the measurements over the panel and the target were taken within minutes of each other. The coordinates of the measurements were mapped using a Global Navigation Satellite Systems (GNSS) (Figure 8b).

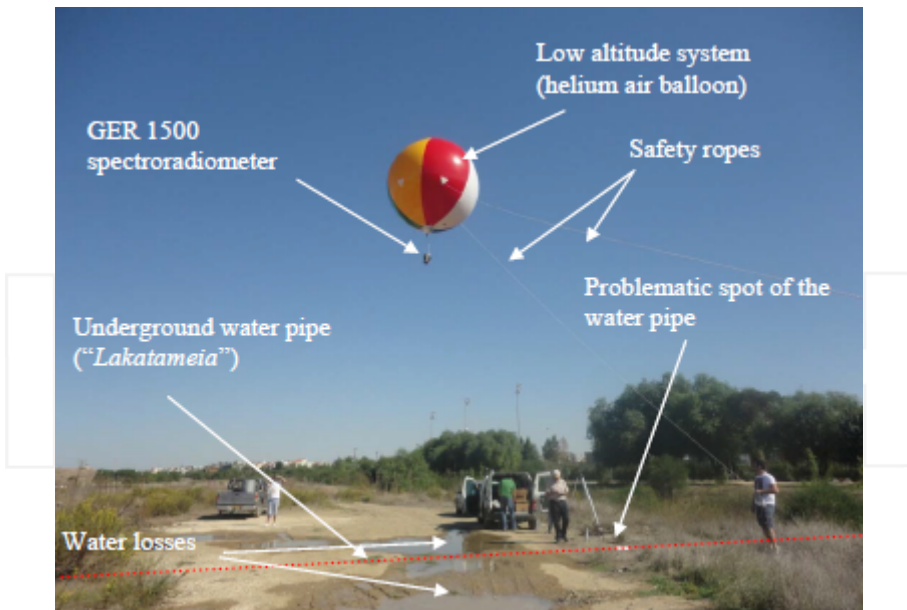
Figure 9. The low altitude system for spectroradiometric data

In addition, spectroradiometric measurements were taken from a low altitude system (Figure 9). The spectroradiometer was attached to the air balloon and raised over the pilot study area. Measurements were taken at several heights in the pilot study area and also in the surrounding area in order to compare their spectral signature profiles. As the airborne system was raised, the pixel size of the ground increased.
