***Seismic Performance of Historical and  
Monumental Structures***

# Seismic Performance of Historical and Monumental Structures

Halil Sezen and Adem Dogangun

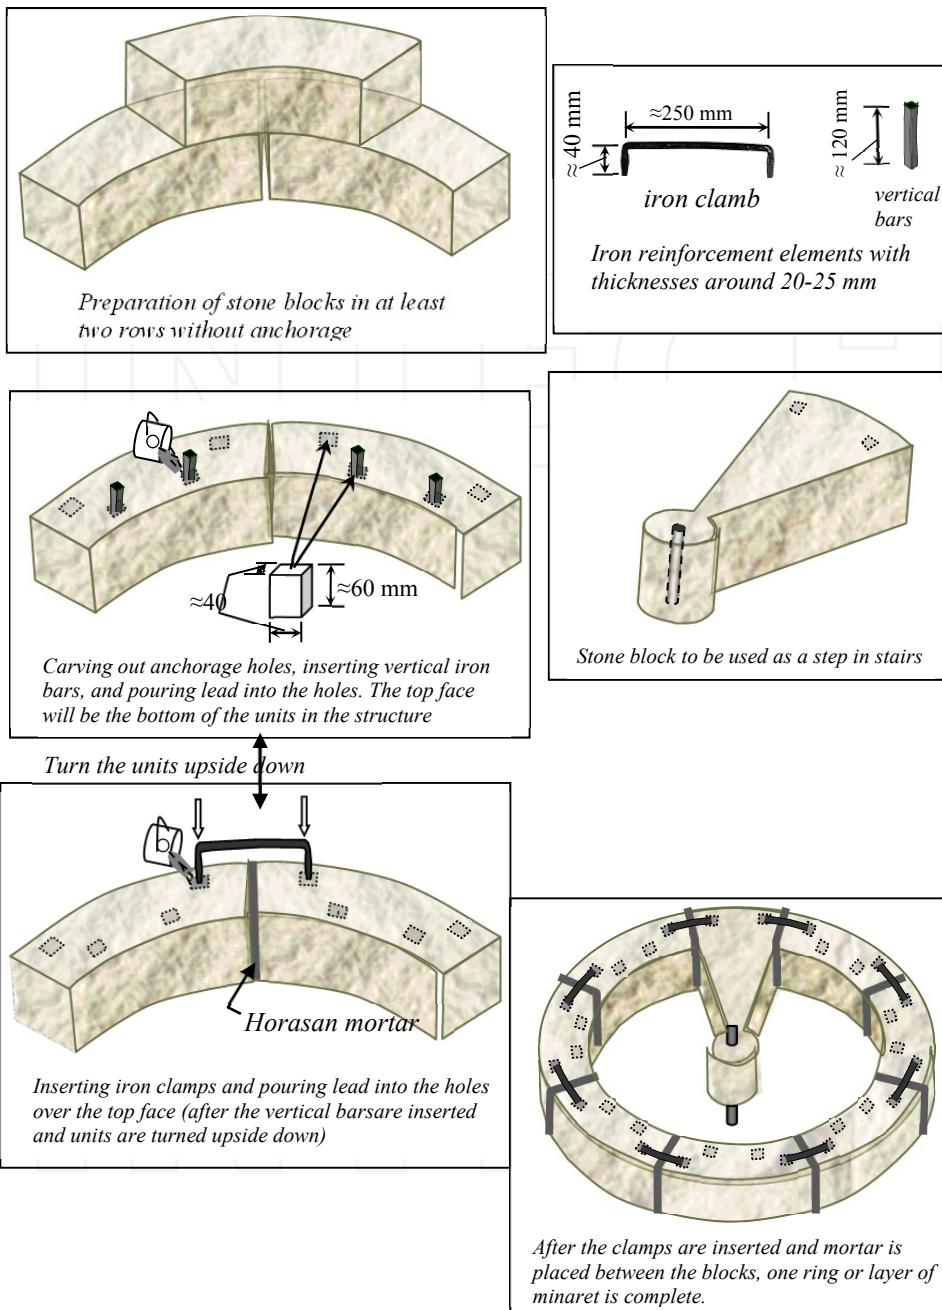
After a major earthquake in 1509, Ottoman architects tackled the problem of constructing tall earthquake resistant minarets (Oğuzmert, 2002). They started to use a special technique for linking adjacent stone blocks with iron bars and clamps in the vertical and horizontal directions as shown in Figure 3 (Doğangün et al. 2007). Use of iron clamps in the two perpendicular directions (transverse and vertical) has improved the lateral load carrying capacity of slender masonry minarets significantly under earthquake loads. The clamps and vertical bars were placed inside anchorage holes in the stone blocks, and melted lead was poured inside the hole to provide bond between the stone and iron clamp or vertical bars. Depending on the properties and dimensions of the stone units, different clamps were developed. For example, as shown in Figure 4a, curved clamps were used within the circular stone wall on the minaret perimeter. Sharper and thinner clamps in thin stone blocks (Figure 4b) and shorter clamps were used if low tensile stresses are expected (Figure 4c). Approximately 2000 kilograms of this heavy metal, lead was used for the construction of a typical masonry minaret. Lead performs as intended for a very long time because it does not corrode or is hardly ever influenced by the adverse environmental conditions.

**Figure 3.** Construction of traditional Turkish minarets using stone blocks reinforced and anchored with iron bars and clamps (Dogangun et al. 2007)

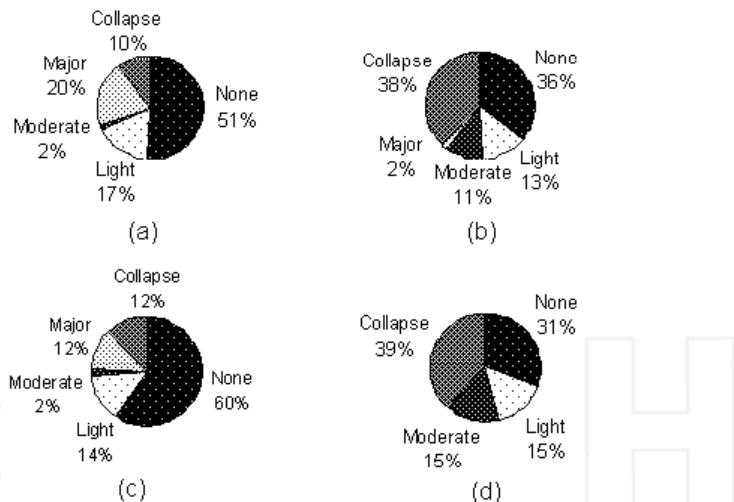
**Figure 6.** Damage distribution for (a) all mosques and (b) all minarets, and damage distribution for (c) RC mosques and (d) RC minarets

Comparison of Figures 6a and 6c indicates that the damage in RC mosques was less as compared to other structural systems. More than ten percent of the mosques surveyed collapsed. Three of the 26 mosques surveyed in Duzce and Kaynasli region collapsed. There was no collapsed mosque in Bolu, but five of the 21 mosques surveyed had to be closed after the October 12, 1999 earthquake. Closed Mosques in Bolu were Semsi Ahmet Pasa (Imaret),

As illustrated in Figures 6b and 6d, percentage of all damaged minarets and only RC minarets are similar. Almost forty percent of the minarets collapsed, and approximately one third of the minarets were undamaged. Failure plane for almost all collapsed RC minarets was within 1.5 meter long region above the minaret base or pyramid-shaped transition segment (Figure 7a), where the longitudinal reinforcing bars were usually spliced. Horizontal circumferential cracks and spalling of concrete were commonly observed at the bottom of the cylindrical body of RC minarets (Figure 7a). Frequently, flexural cracks, concrete crushing or spalling was observed in this region of the damaged RC minarets. As shown in Figure 7, less frequently collapse or damage occurred within the transition segment and middle of the cylindrical body or near the top of the minaret.

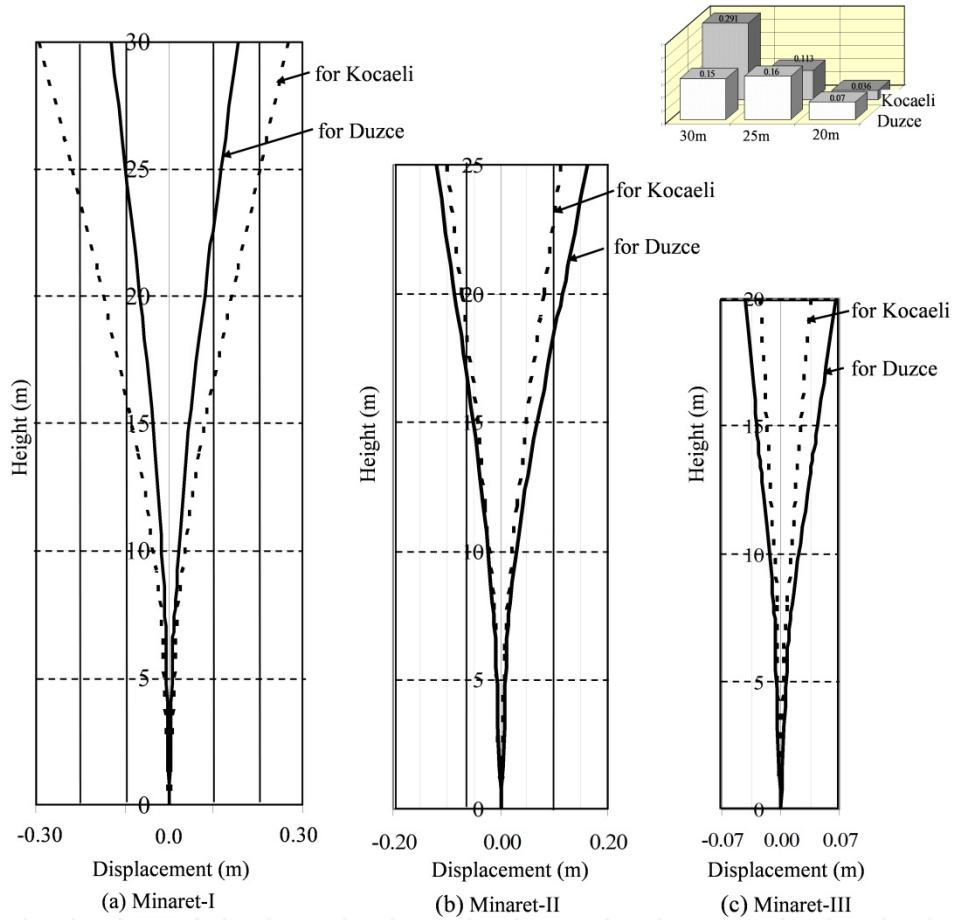
**Figure 14.** Lateral displacement distribution over the height of minarets for Duzce and Kocaeli ground motions

Figure 14 shows the calculated maximum elastic lateral displacement distribution along the length of three minaret models subjected to 1999 Duzce and Kocaeli earthquake ground motions. As shown in Figure 14 the deflected shapes of the minarets appear to show flexure dominated response with the largest displacements calculated at the top. Although the minarets act as cantilevers, the deformations are much smaller over the height of relatively stiff 6 m high base or boot. The displacements start to increase above the transition segment at about 8 m from ground level. The maximum dynamic displacement of Minaret I is 88%

larger for the Kocaeli input motion (0.291 m) than that for the Duzce ground motion (0.154 m), although the maximum acceleration of the Duzce motion was larger. For the other two shorter minarets Minaret I and II, the maximum calculated displacements are larger for the Duzce ground motion. The maximum dynamic lateral displacement of 0.29 m calculated for the 30 m tall minaret under Kocaeli earthquake exceeds the TEC (2007) code limit of 0.20 m for the Minaret I model (Dogangun et al. 2008).

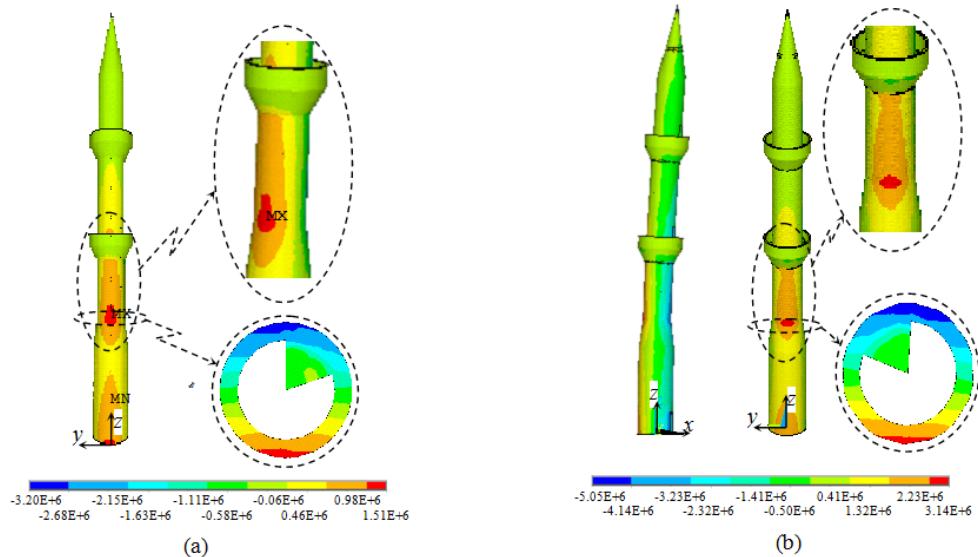
The most critical axial stress contours calculated during the dynamic analysis of minaret models are shown in Figure 15. The maximum tensile and compressive stresses occur at a height of 8 m, immediately above the transition zone (Figure 12). This is consistent with the most common minaret failure mode observed in the field after the earthquakes (Figures 7a, 8a and 8b). The minaret models used here were stand-alone fixed-ended cantilevers, which did have any lateral support over their height. Nevertheless, in some cases one side of the minaret boot or base (bottom 6 m of the minaret models) are supported by or attached to the mosque structure (Type II in Table 4, e.g., Figures 8a and 8b). Such a partial lateral support, even on one side, provides added stiffness near the bottom of the minaret. This will further increase failure potential at the top of the transition zone as shown in Figures 7a, 8a, 8b and 14.

**Figure 15.** Maximum stress contours for Minaret-I under: a) Duzce, and b) Kocaeli records
